# Diagnostic of generator partial discharge and acoustic imaging scheme for monitoring winding health condition and repair

**Abstract**—Partial discharge in a generator is a phenomenon of electrical discharge that occurs in the generator winding insulation. This phenomenon, if it continues, will cause the generator winding insulation failure. Therefore, partial discharge needs to be monitored, both on-line and off-line. Currently, partial discharge monitoring equipment has been installed at the Cirata Hydroelectric Power Plant (PLTA Cirata), and routine off-line partial discharge testing has been carried out. With this data, it can be used as a reference for the necessary generator maintenance. If the partial discharge trending value increases 2 times in a year, maintenance is required. During maintenance, acoustic imager testing is carried out to map the location of the partial discharge. By combining the three types of testing, a good generator monitoring system will be obtained, and the right type of maintenance will be determined according to the partial discharge mapping results. The analysis begins by conducting on-line and off-line partial discharge trending. If the trendin

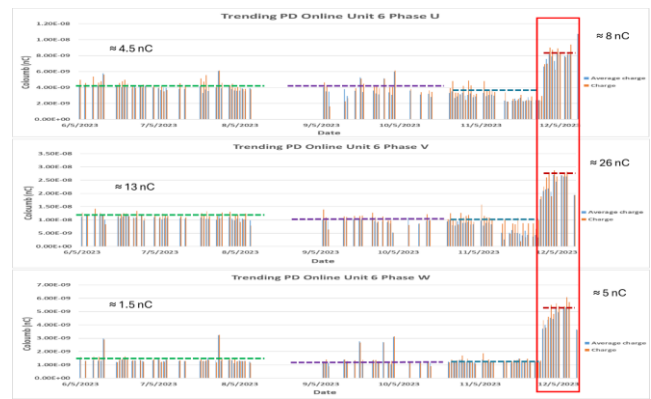
Fig. 5. Trending PD online June – December 2023

Fig. 5. shows the trend graph of PD values from June to December 2023 taken from the ARGOS Monitoring System [21]. From the graph, it can be seen that the PD value has increased 2-fold over 6 months. The highest increase trend occurred in December 2023 in the S phase from 13 nC to 26 nC.

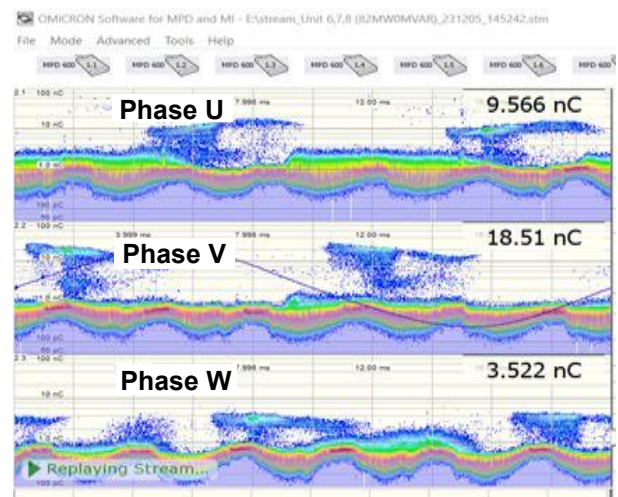
(a)

To find out the cause of the increase in PD value, it can be seen from the PRPD pattern. Fig. 6 shows the PD pattern taken from the MPD600 streaming. Based on the PRPD pattern, the increase in PD value occurs in the end winding area of the generator stator winding [22-23]. The cause of this increase in PD can be caused by humidity, contaminants and end winding vibration [8-9]. If it lasts for a long time, it can cause deterioration of the winding insulation. Therefore, it is necessary to conduct an off-line PD test and visual inspection of the generator winding to verify the results of the on-line PD.

Fig. 6. (a)Streaming PRPD pattern MPD600 (b)Typical PRPD pattern [22-23]

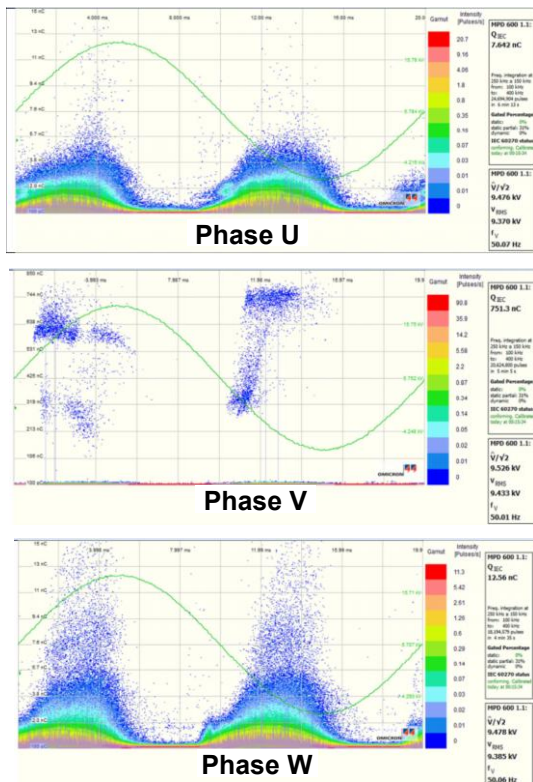
Fig. 7. PRPD Pattern

From Table I it is concluded that the V phase experienced a very significant increase compared to other phases. This is in accordance with the results of on-line PD, where the PD value of the V phase is higher than the other phases. However, for the U and W phases, the off-line PD value of the W phase is higher than the U phase, this is inversely proportional to the on-line PD results. This can occur because the test conditions during operation and shutdown are different, especially related to the voltage level received by the coil bar [22]. Fig. 7 shows the PRPD pattern of the off-line PD of the U, V and W phases.

From the PD pattern in Fig. 7, phase V has the highest PD value and the typical pattern indicates end winding discharge. This result is in accordance with the indication produced by the on-line PD pattern. With the on-line and off-line PD results indicating an increase in PD value and the same pattern, it is necessary to plan maintenance / overhaul actions. In June 2024, an overhaul was carried out and an

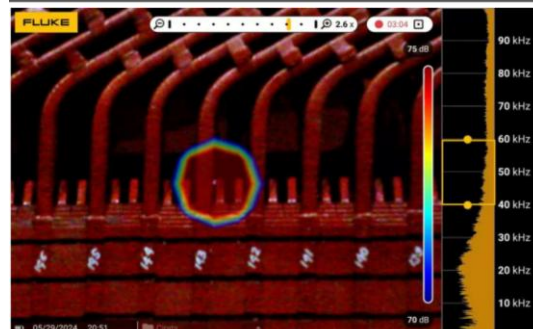
Acoustic imager testing was conducted during the June 2024 overhaul, along with off-line PD testing. The mapping results are shown in Table III. According to the mapping results, the high intensity point is in phase V (75 dB), slot number 143.

The PD type in slot 143 based on the corona imager results is external (corona, arcing), as seen in Fig. 7.a. After knowing the discharge point, verification is carried out with visual inspection. In Fig. 7.b, the insulation condition is starting to deteriorate, so repairs need to be made.

1st Run Test Voltage @ 9500 V, Corona At slot 143 Arching (Surface Discharge) Area NDE Discharge Type : External (Corona / Arcing) :-

Fig. 7. Slot 143 inspection (a).Visible light from the acoustic imager, (b).Visual inspection
