# Diagnostic of generator partial discharge and acoustic imaging scheme for monitoring winding health condition and repair

**Abstract**—Partial discharge in a generator is a phenomenon of electrical discharge that occurs in the generator winding insulation. This phenomenon, if it continues, will cause the generator winding insulation failure. Therefore, partial discharge needs to be monitored, both on-line and off-line. Currently, partial discharge monitoring equipment has been installed at the Cirata Hydroelectric Power Plant (PLTA Cirata), and routine off-line partial discharge testing has been carried out. With this data, it can be used as a reference for the necessary generator maintenance. If the partial discharge trending value increases 2 times in a year, maintenance is required. During maintenance, acoustic imager testing is carried out to map the location of the partial discharge. By combining the three types of testing, a good generator monitoring system will be obtained, and the right type of maintenance will be determined according to the partial discharge mapping results. The analysis begins by conducting on-line and off-line partial discharge trending. If the trendin

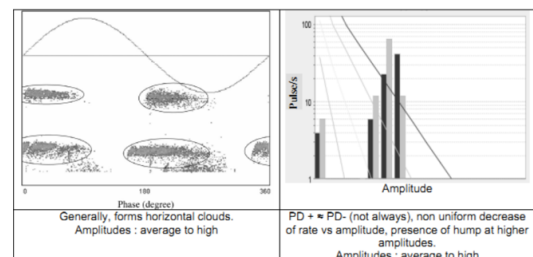
(b)

To find out the cause of the increase in PD value, it can be seen from the PRPD pattern. Fig. 6 shows the PD pattern taken from the MPD600 streaming. Based on the PRPD pattern, the increase in PD value occurs in the end winding area of the generator stator winding [22-23]. The cause of this increase in PD can be caused by humidity, contaminants and end winding vibration [8-9]. If it lasts for a long time, it can cause deterioration of the winding insulation. Therefore, it is necessary to conduct an off-line PD test and visual inspection of the generator winding to verify the results of the on-line PD.

Fig. 6. (a)Streaming PRPD pattern MPD600 (b)Typical PRPD pattern [22-23]
